Manhole Inspection Summary

Manhole # S15A1_007MH

Insp Date: **7/30/09 11:18 AM**

Location Address: **2916 INVERNESS AV**

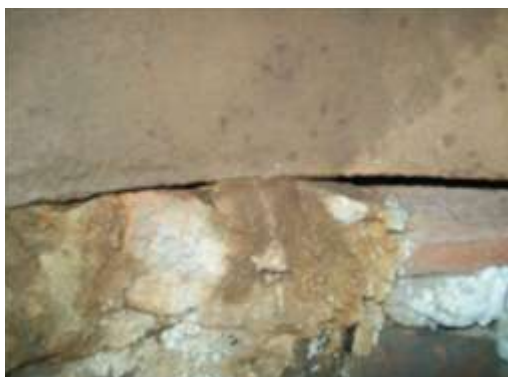
Defect 1

Condition: ☐ Sound ☐ Cracked ☐ Root Intrusion ☐ Loose Brick ☒ **Deteriorated**

Infiltration: ☐ None ☒ **Joint** ☐ Cracks ☐ Mortar ☐ Roots ☐ Wall

chimney deteriorated with infiltration from joint

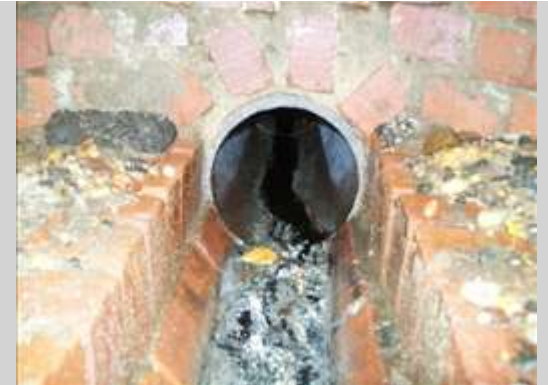
12 O'Clock Outflow

8 in. Circular Gravity Sewer
Pipe Out @ 12 O'Clock

Pipe Height: **8.4** (in.) Rod and Bar (Angled)
Pipe Material: **Clay** ☐ Pipe Lined
Invert Depth: **10.33** (ft.) Flow Characteristics: **Slow**
Deposits: ☒ None ☐ Mud ☐ Sludge ☐ Debris ☐ Grease
Silt Depth: **0** (in.) Deposits Extent:
Infiltration: **None** Pipe Seal Cond: **Sound**

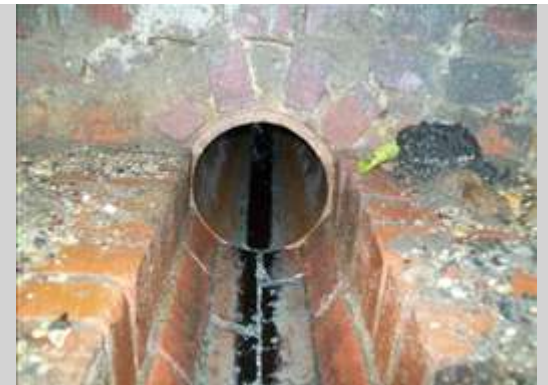
6 O'Clock Inflow

8 in. Circular Gravity Sewer
Pipe In @ 6 O'Clock

Pipe Height: **8.4** (in.) Rod and Bar (Angled)
Pipe Material: **Clay** ☐ Pipe Lined
Invert Depth: **10.20** (ft.) Flow Characteristics: **Slow**
Deposits: ☒ None ☐ Mud ☐ Sludge ☐ Debris ☐ Grease
Silt Depth: **0** (in.) Deposits Extent:
Infiltration: **None** Pipe Seal Cond: **Sound**
